Ambient Environmental, Inc.
Comprehensive Building Science Solutions

Phase I Environmental Site Assessment

Site Location: Elk and Sherman Street Lots, Albany, NY

Ambient Project No. 170616ENVA

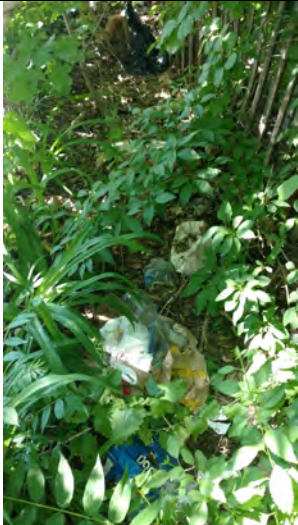
<p>Photograph 1</p> <p>Example of trash and debris found on Site.</p>

At the time of the Phase I ESA site visit, all portions of the lots were vacant and unused. Numerous tires, PVC pipes, motor oil, pails, trash cans, and garbage were observed, particularly at the lots located at 238-242 Elk Street (Attachment D, Photographs 1 and 2). A small “hole” was observed at 238 Elk Street at the West end of the property (Attachment D, Photograph 3).

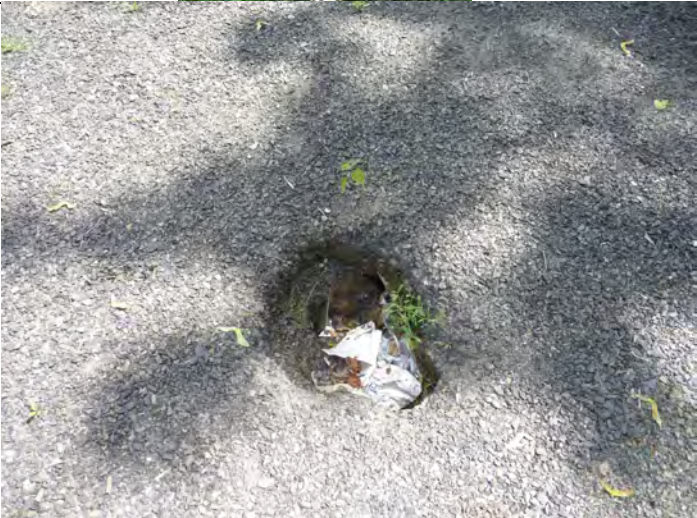
<p>Photograph 3</p> <p>"Hole" found at former footprint of building at 236 Elk Street.</p>

One hole was observed in the crusher run at the newly demolished building at 238 Elk Street (Attachment D, Photograph 3).

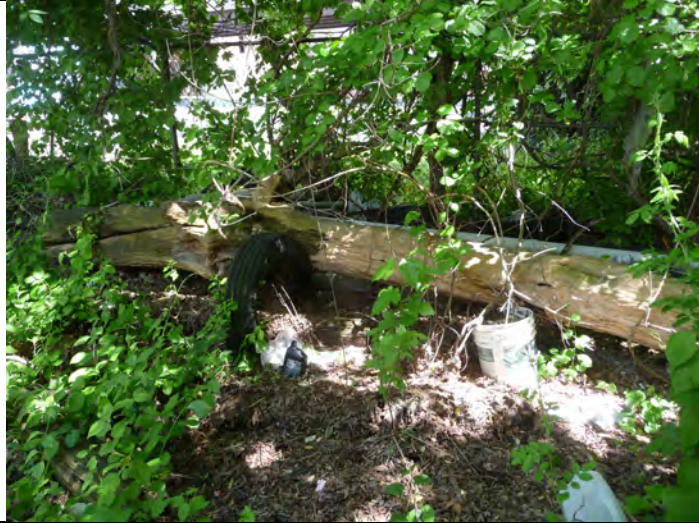
Photograph 4

Numerous motor oil containers and tires were observed due to dumping on the Site (Attachment D, Photograph 4).

Tires and oil containers observed at 242 Elk Street.

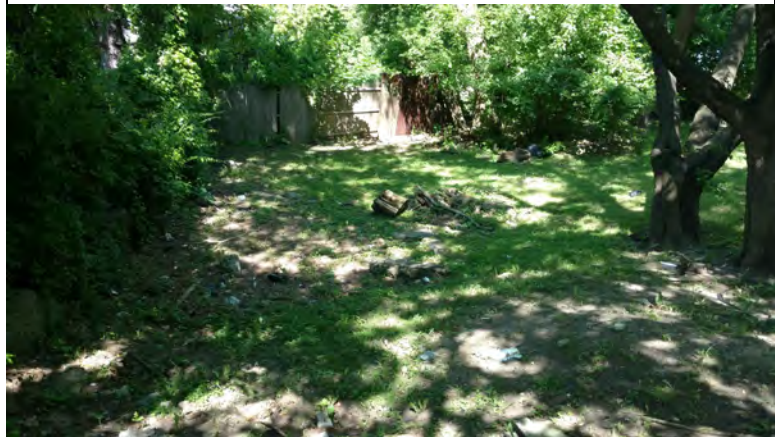
Photograph 5

Upon complete inspection of the ground surface at the Site, stained soil or pavement was not observed. Some areas of stressed soil, particularly at 61 Elk Street were observed (Attachment D, Photograph 5).

Stressed vegetation at 61 Sherman Street.

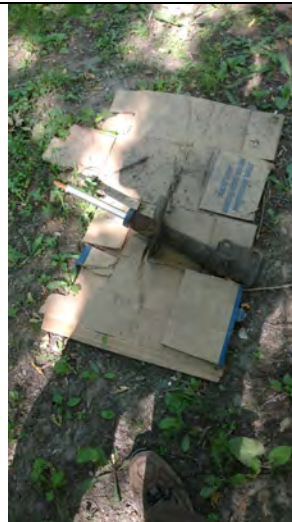
Photograph 6

Car parts observed at 61 Sherman Street.
